# השקיית יער משולב במרעה בקולחי רפת/בית במרכז רמה"ג כאמצעי בטוח לסילוקם

פנחס פיין, עודד בר-שלום, אנה בריוזקין, שושנה  
סוריאנו, זאב גרסטל, אחמד נאסר, ניר עצמון, יוסי משה,  
דורון מרקל, אורן רייכמן

מנהל המחקר החקלאי, המכון לחקר הגולן, רשות המים

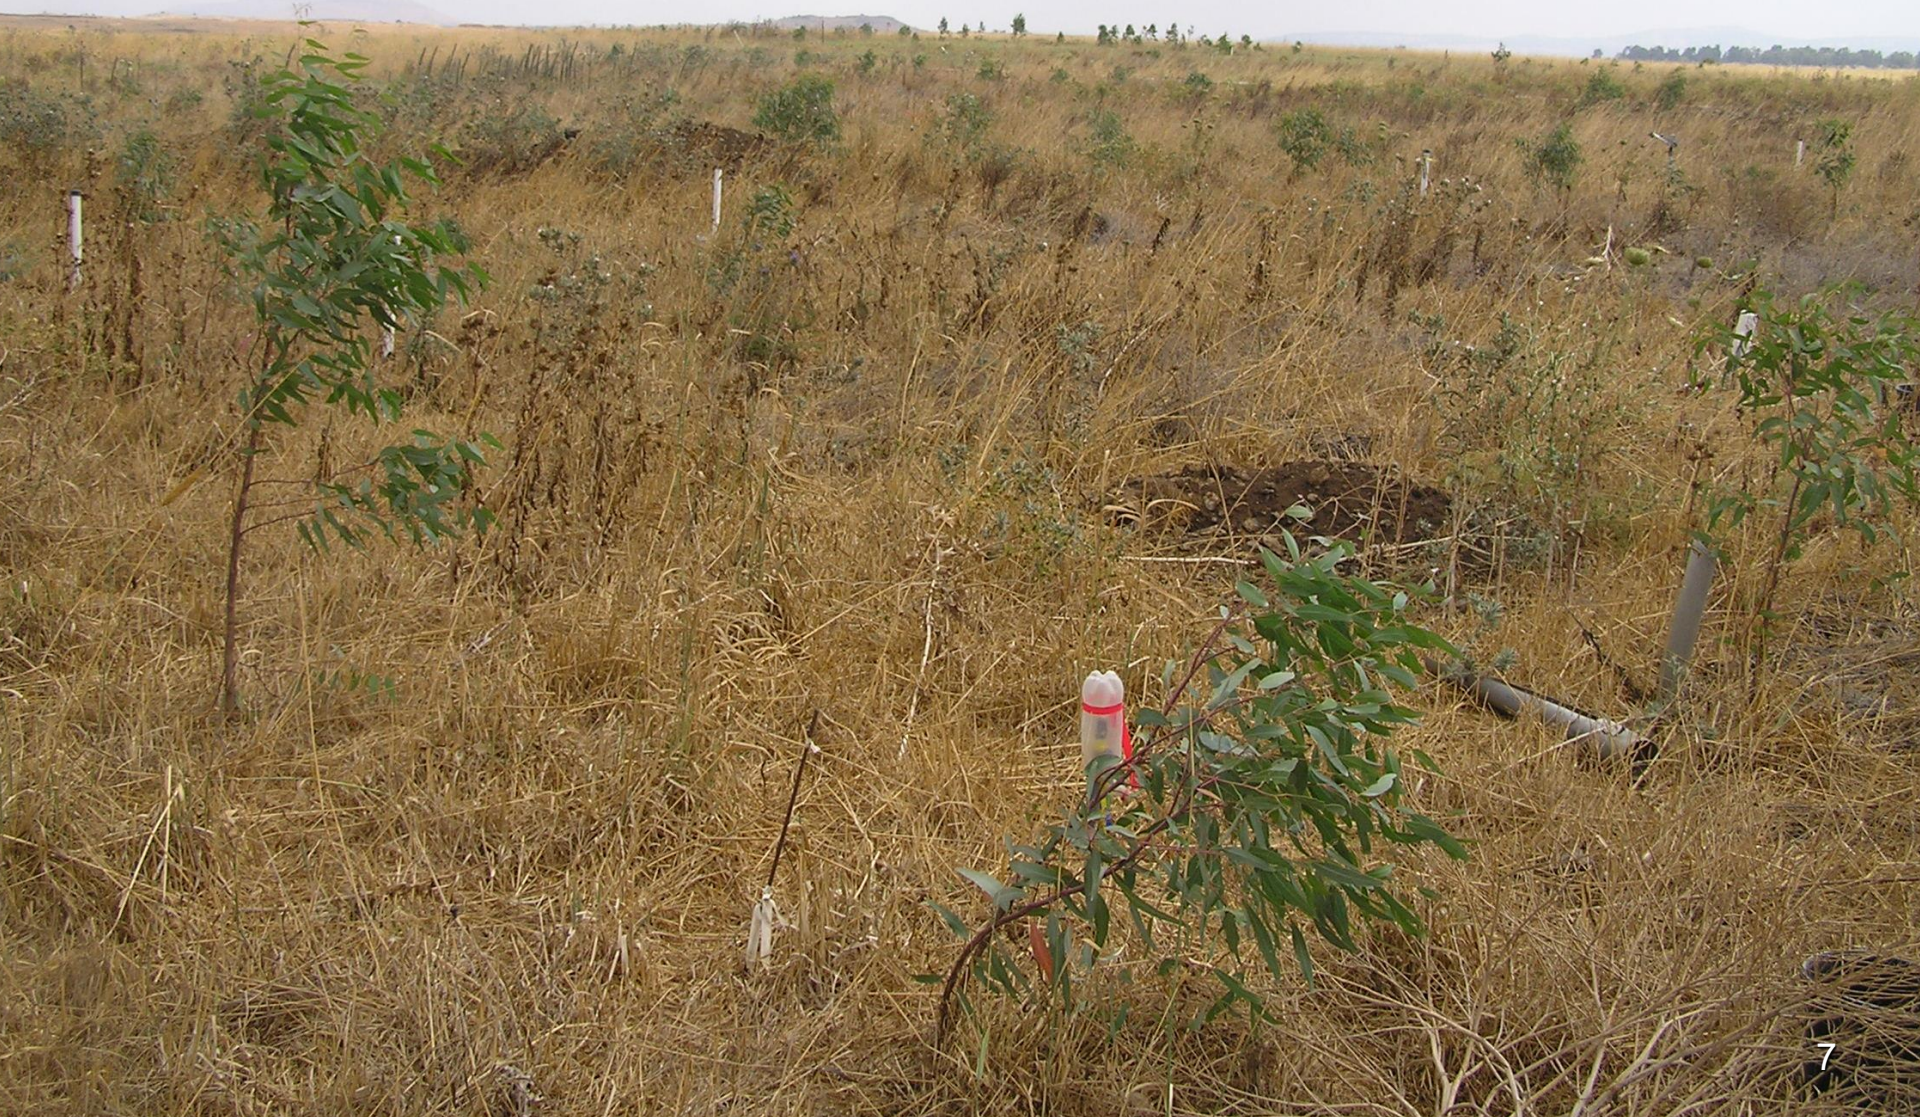
# 12 years after planting

2, 15, & 30-m meters spacing between tree rows

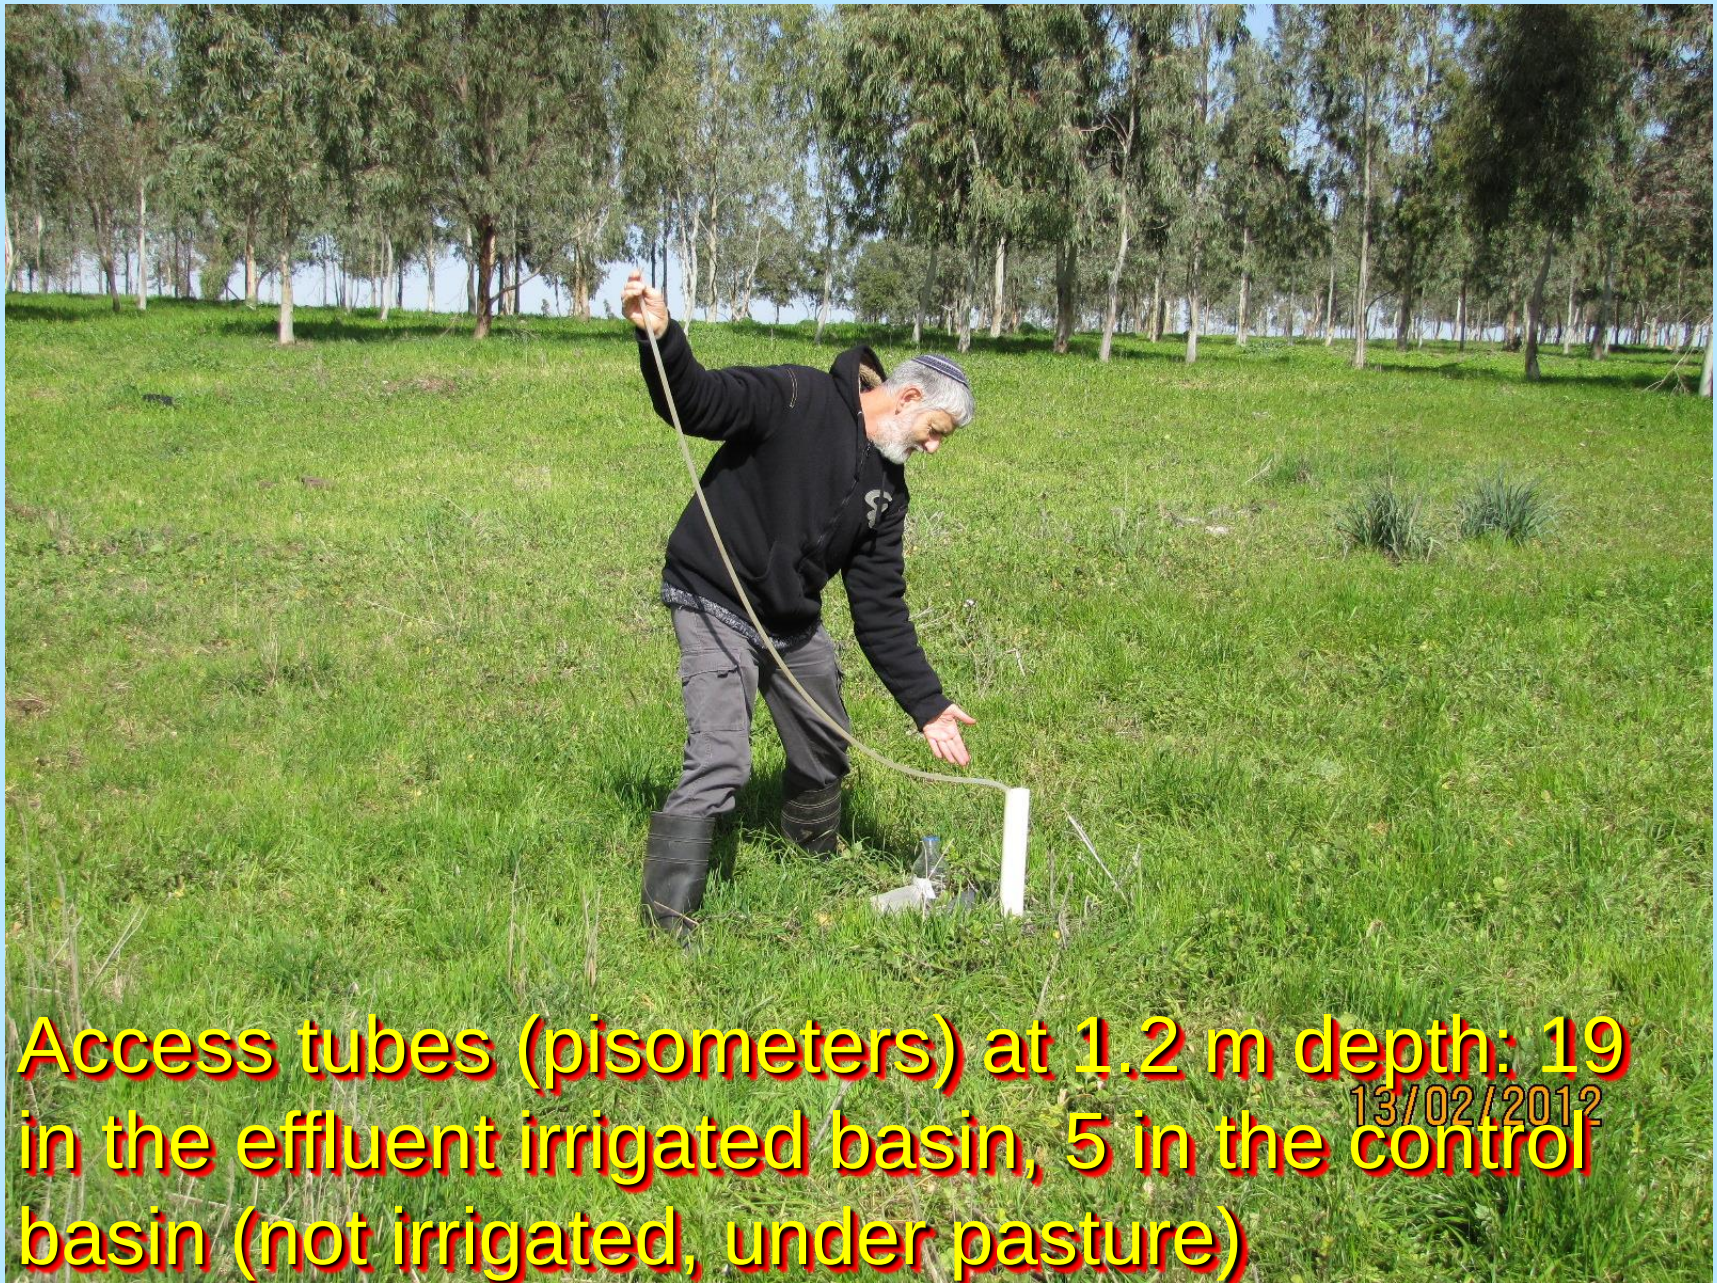
Access tubes (pisometers) at 1.2 m depth: 19  
in the effluent irrigated basin, 5 in the control  
basin (not irrigated, under pasture)

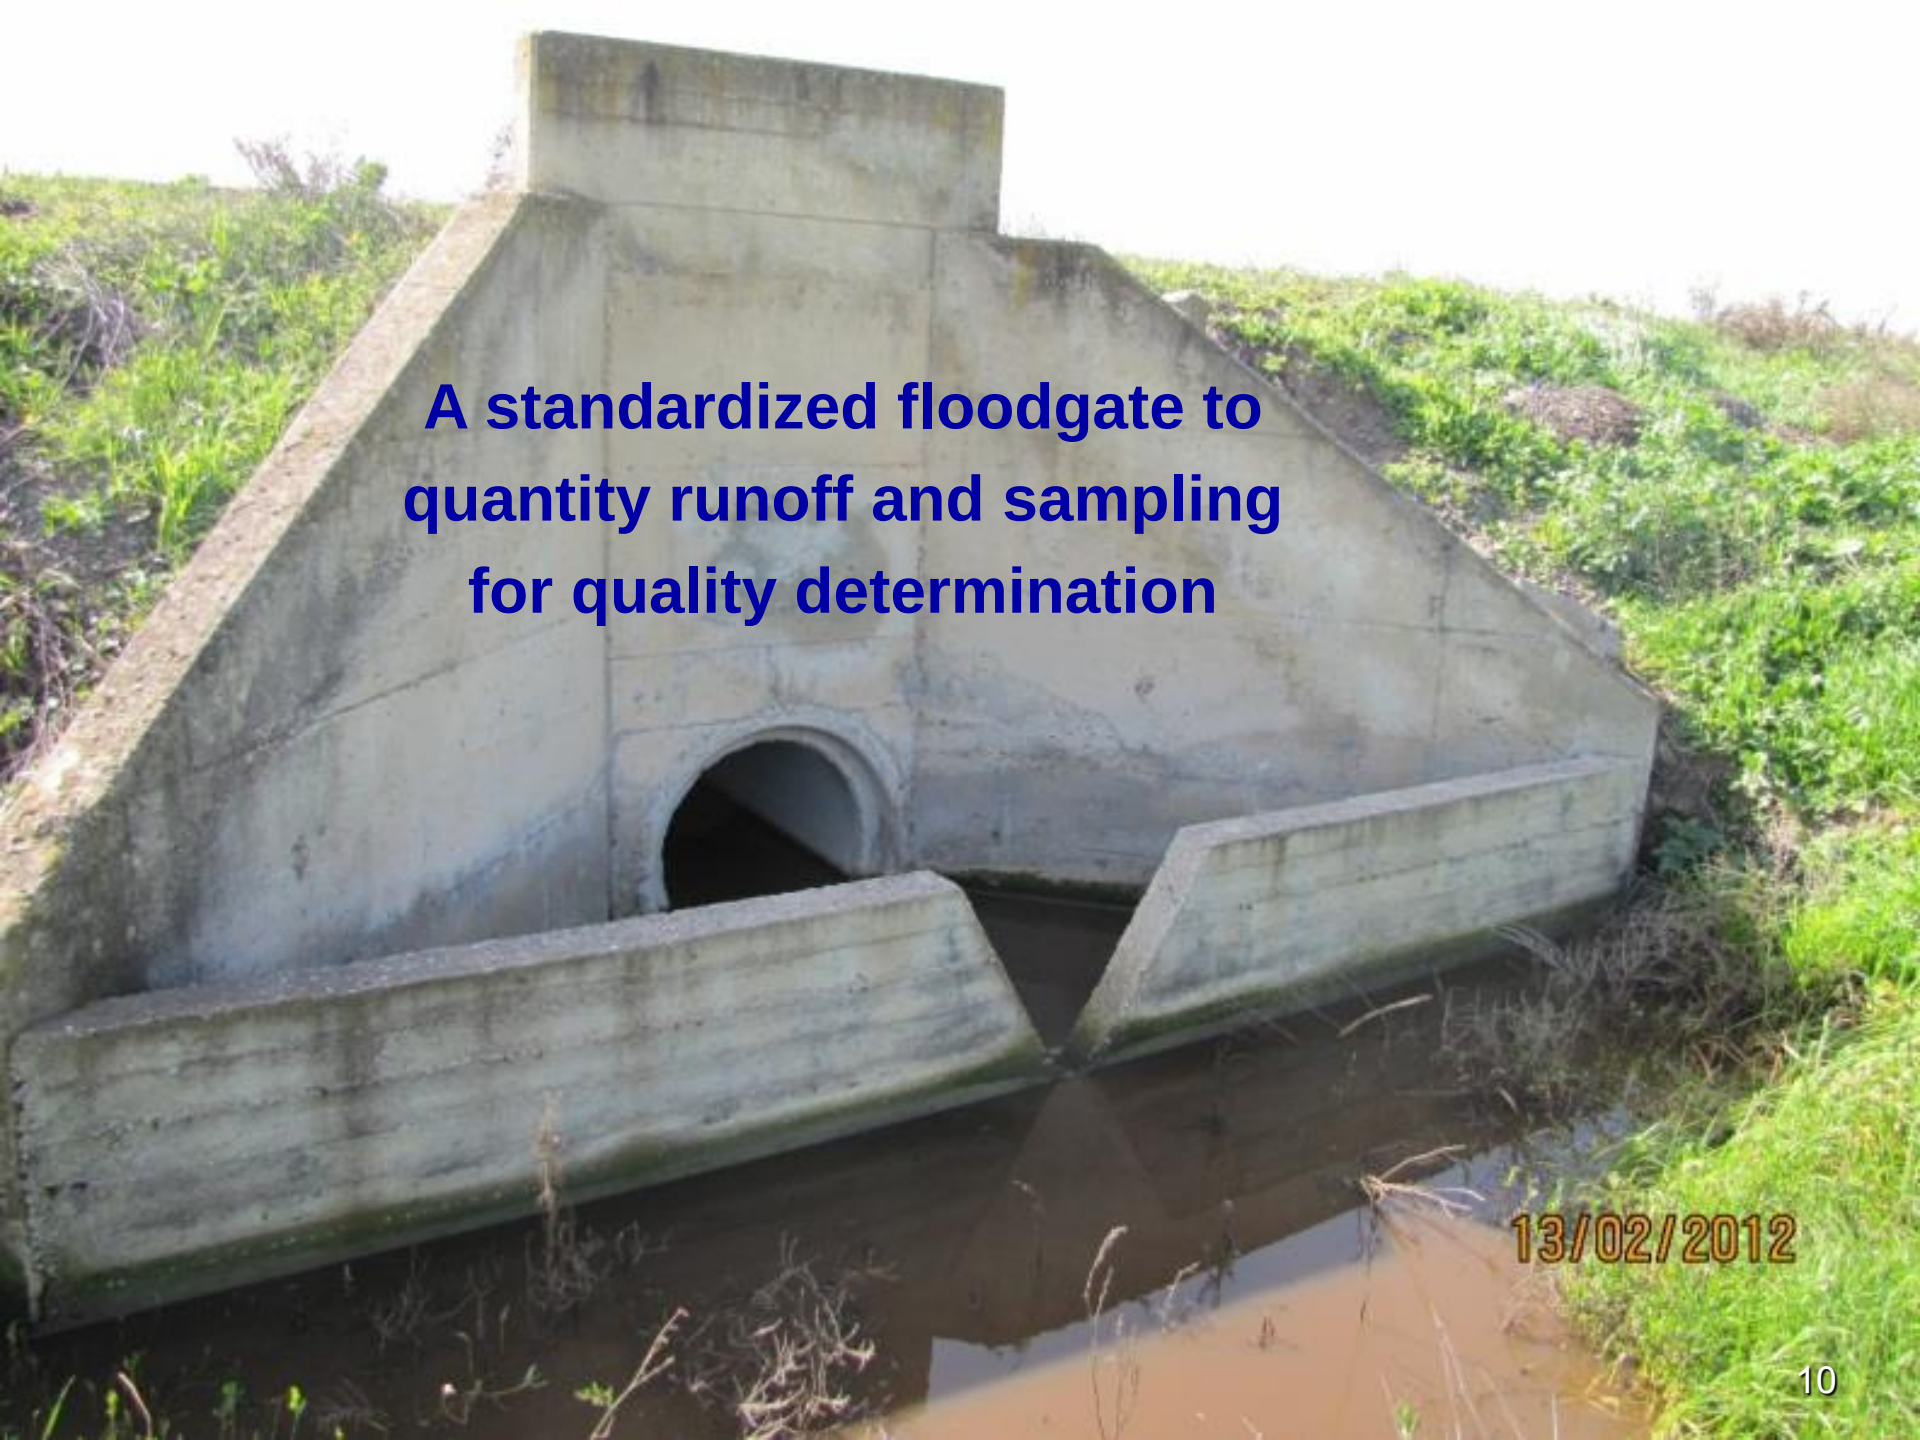
A photograph of a concrete floodgate structure. The structure is made of light-colored concrete and features a large circular opening in the center. It is flanked by two sloped concrete walls that lead down to a body of water. The surrounding area is covered in green grass and some dry vegetation. The sky is bright and clear.

**A standardized floodgate to  
quantity runoff and sampling  
for quality determination**
